Field Service Report

Exchange of stage 1 HPC blades & HPC blades cleaning LM6000 PC SAC

Serial Number: 191-557

Field Service Report
Intervention
 LM6000 PC SAC

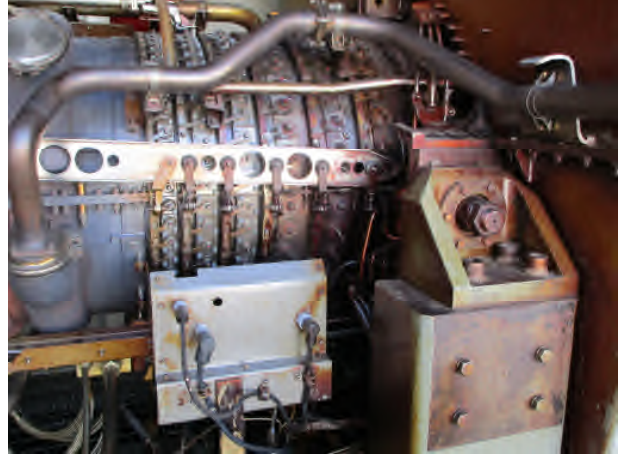
- GT external overview: claret red, sticky discoloration around the HP compressor section, lube and scavenge pump, liquid fuel manifold as well as VBV duct is visible. This might be caused by a fuel leak previously. No abnormalities at leak check during test run to report.
- VBV duct: the bellow found slightly damaged but the function is given. No air leaks were visible. UTE staff is informed.
- All HPC Stage 3 - 5 washer / bushings were found in very worn condition (~25000 running hours)
- The HP section (rotor / stator) was found in slightly dirty condition
- Left hand side: master lever - stage igv clevis was found with a damaged viton boot (cracked) but the function is still given. On the right hand side stage igv clevis viton boot is missing and has been repaired temporary with rtv red silicone.

Picture 2: Discolorations on VBV duct

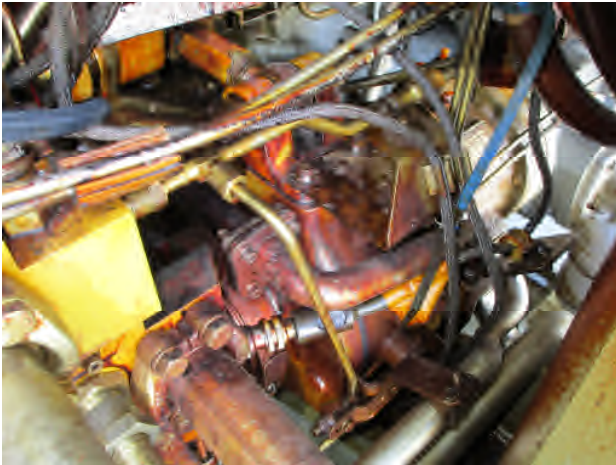
Picture 3: Discoloration on lube & scavenge pump

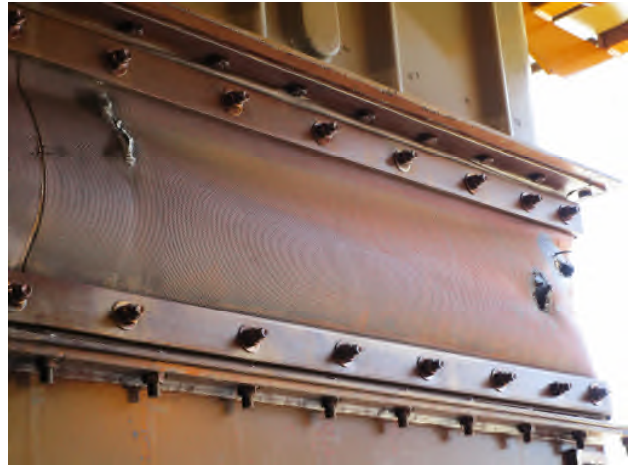
Picture 4: VBV duct bellow - damages

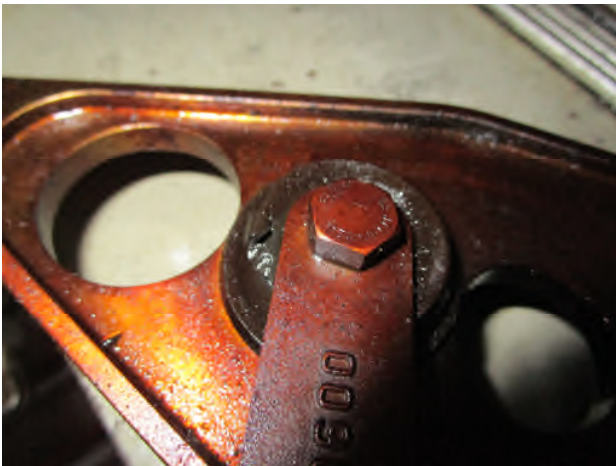
Picture 5: Viton boot left hand side with crack

- Installation of new stage igv viton boots on both master lever and check of condition of the remaining boots during the next intervention.
- Inspection of HPC stage 3 - 5 washer / bushings during semi annual GT inspection is highly recommended as well as documentation of operation hours for LM 6000 sprint version (12500 scheduled replacement according to GE Manual).

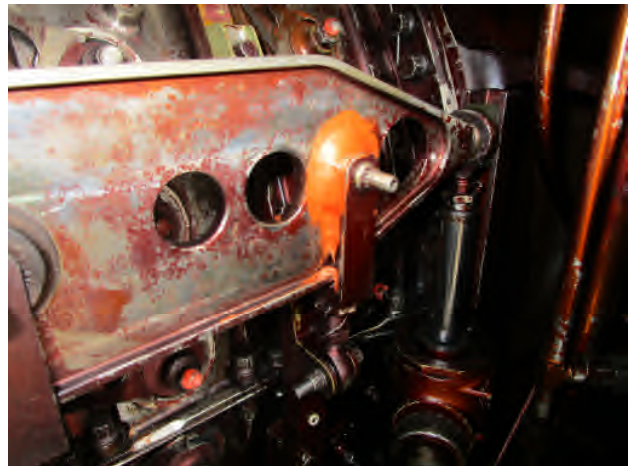
Picture 6: missing viton boot right hand side

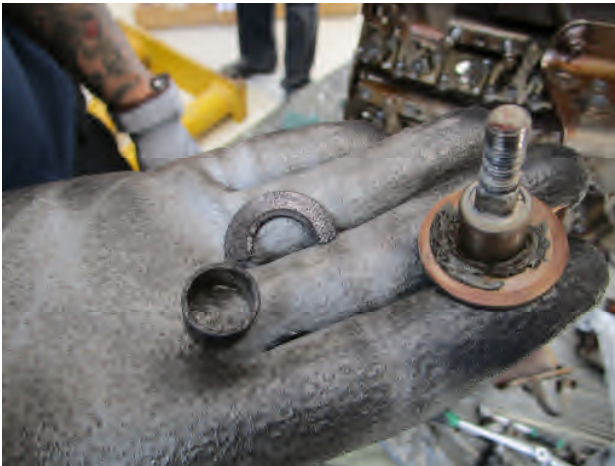
Picture 9: stage 3 - 5 removed bushing condition

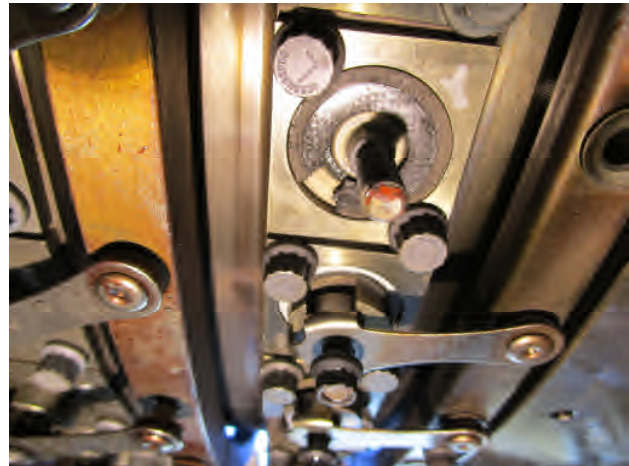
Picture 10: missing washer material stage 5

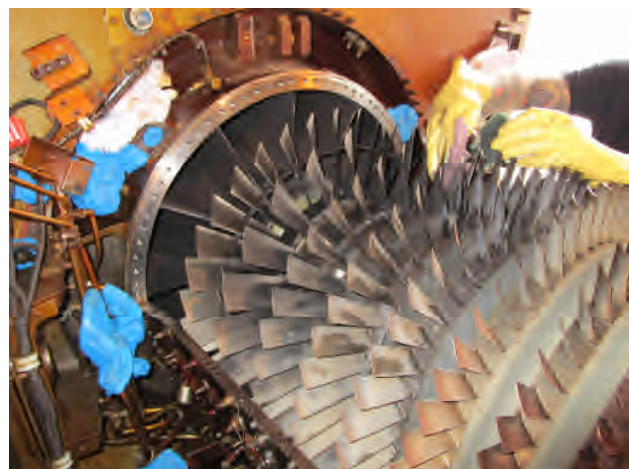
Picture 12: HP compressor section hand cleaning

- Exchange of stage 1 blade set (mid span) including hand cleaning of compressor section as far as possible after top case removal in accordance with GEK 105059 / WP 241300
- Visual inspection of HP compressor section - serviceable
- HPC stage 2 - 4 blade chord length inspection (measurement) and documentation in accordance with GEK 105059 / WP 241300. This was performed on customer request and found within the specifications.
- HPC stage 3 - 5 washer / bushing replacement in accordance with GEK 105059 / WP 241200. This was performed on customer request with parts & tooling (fabricated on site) provided by UTE.
- VSV travel & monitor signal check carried out including leak check during start up. Customer request 1 hour test run at base load was successful and recorded GT parameter were found within the limits.

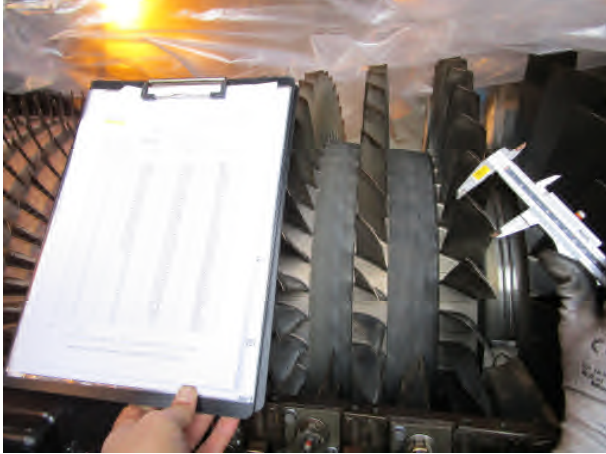
Picture 13: stage 2 - 4 blade chord measurement

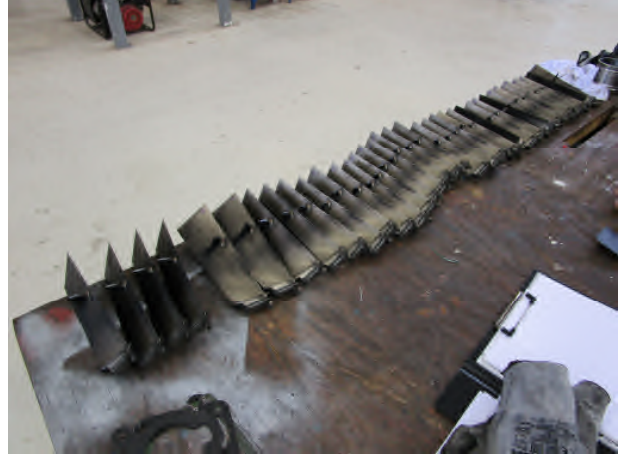
Picture 14: removed stage 1 blade set (36 ea)

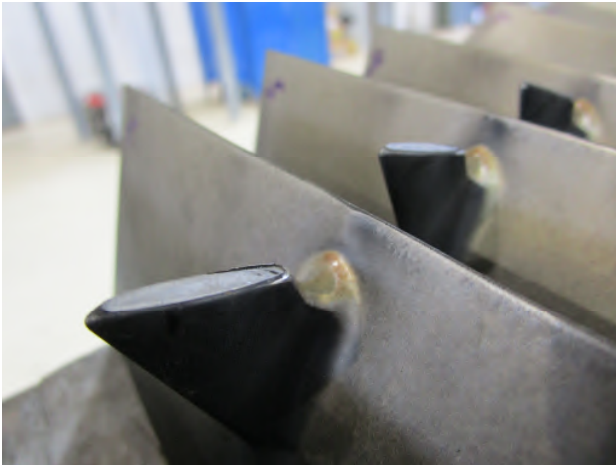
Picture 15: mid span pad condition after removal

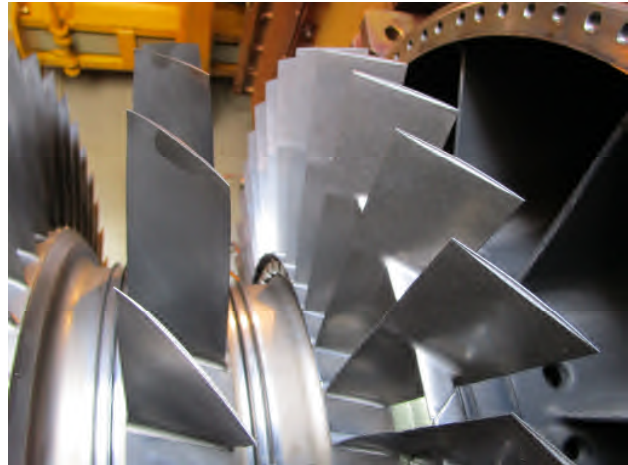
Picture 16: new installed stage 1 blade set
