## Field Service Report

### Exchange of Stage 1 HPC blades and HPC blades cleaning LM6000 PC SAC

**Serial Number:** 191-558

**Date of Visit:** 14.11.16 - 06.12.16

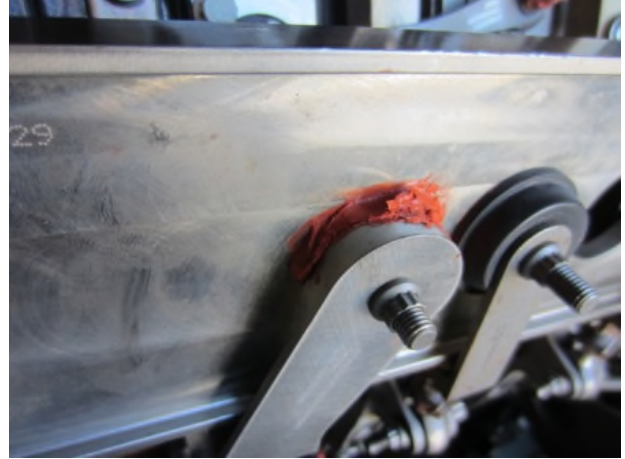
Picture 2: Stage 5 clevis with red silicone

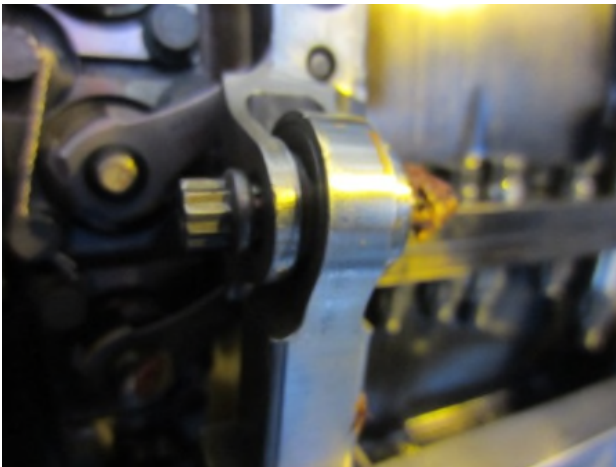
- Right hand side stage 5 connecting link was found installed without the small bushing inside (See additional picture 29 in "general findings")
- At the front frame on the left hand side two bolts are broken and a therefore loose bracket was found. The bracket has been removed and was given to the customer.

Picture 3: Stage 5 conn. link with missing bushing

- Installation of bushing into stage 5 connecting link on the right hand side during the next intervention.
- Installation of missing viton boot at the master lever arm and check of condition of the remaining viton boots during the next intervention.

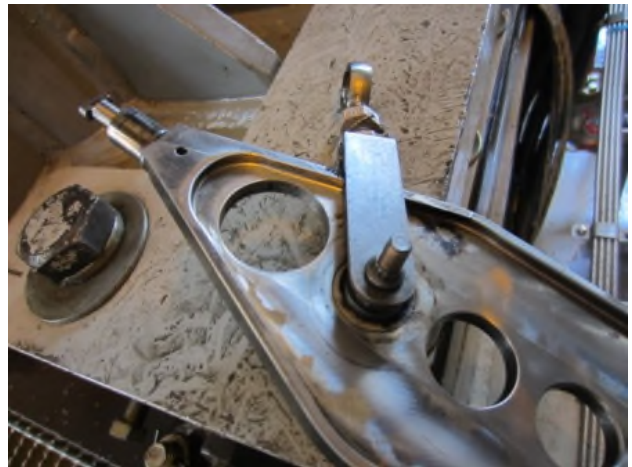
- Below are some findings listed that were found during the job:
- Left hand side stage igv clevis was found with one missing viton boot.
- VSV mount bolts on the right hand side were not safety wired.

Picture 4: L/H stg. IGV clevis with missing boot

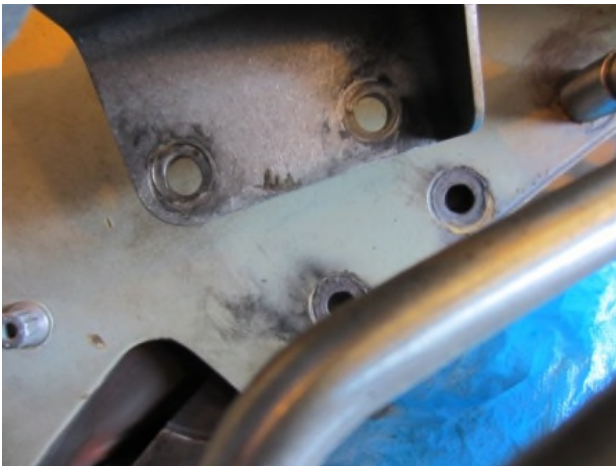
Picture 5: L/H broken front frame bolts

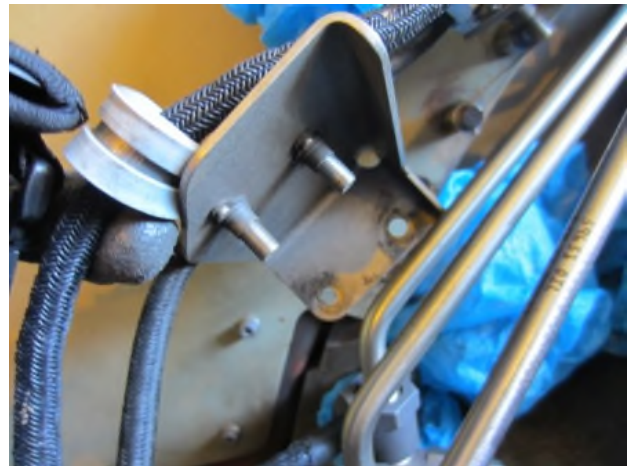
Picture 6: Loose bracket at front frame

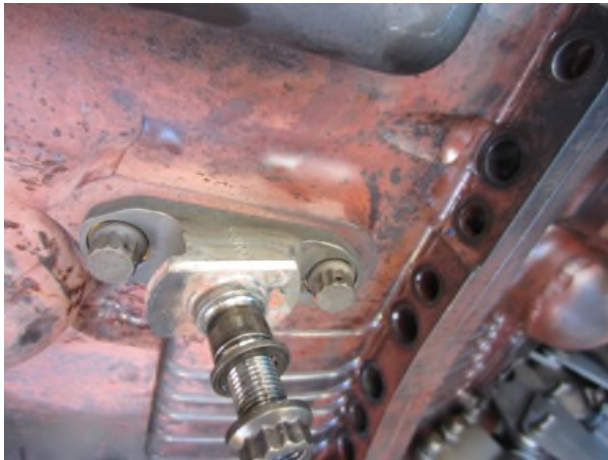
Picture 7: VSV mount bolts without safety wiring

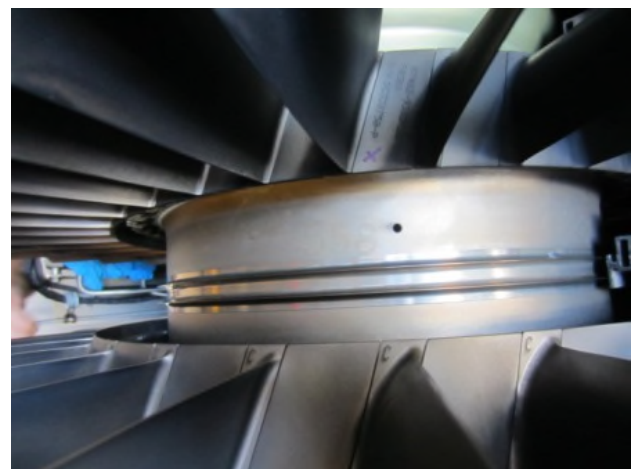
Picture 12: Weep hole without oil traces

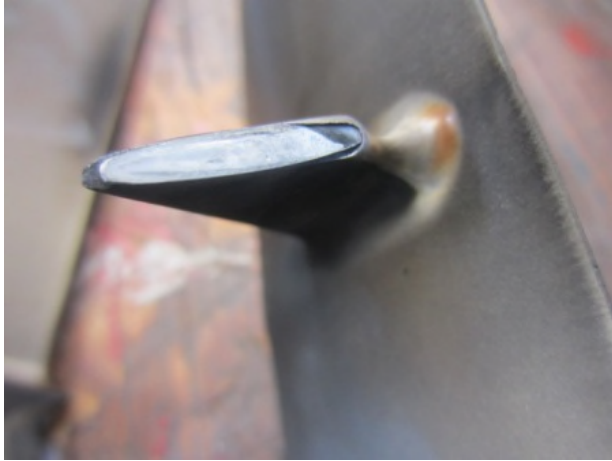
Picture 13: Old mid span damper pad stage 1

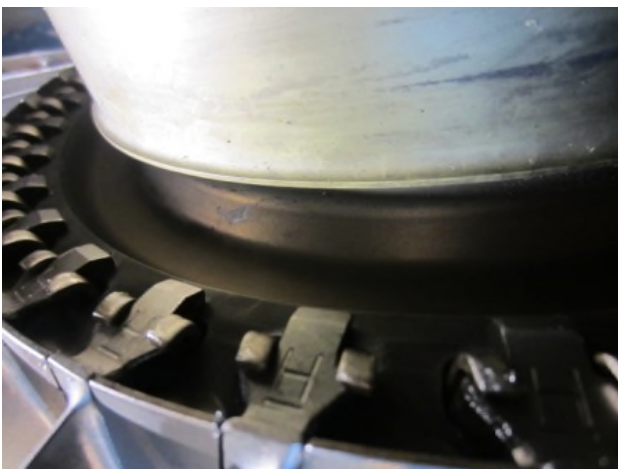
Picture 17: Bended stage 1 blade retainers

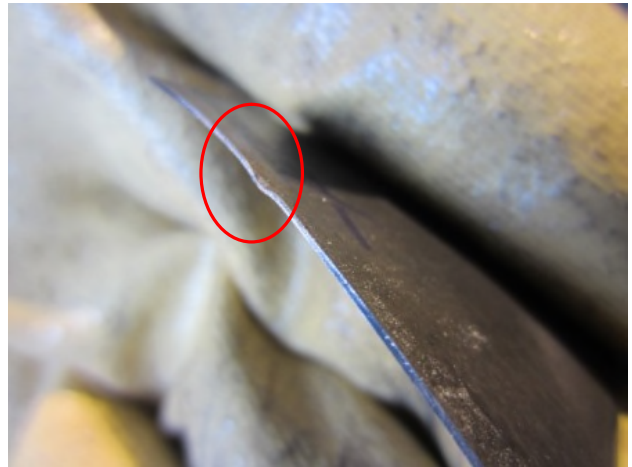
- During the cleaning of the hpc blades, 6 blades in stage 3 were found with small blade tip impacts. Those findings are very small and within the serviceable limits.

Picture 18: 1 of 6 stg. 3 blade tip with small impact

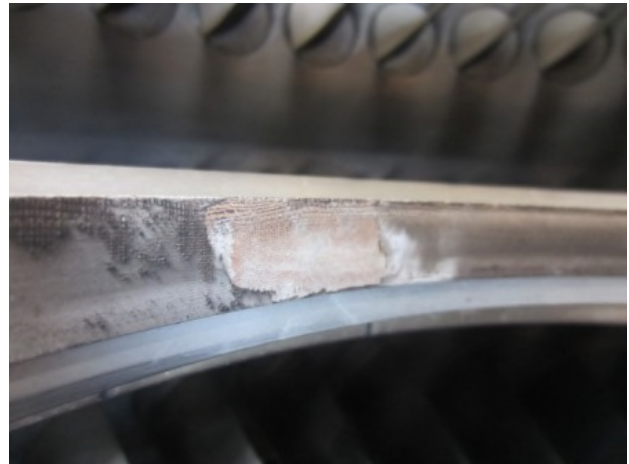
- Whilst the hpc top case was removed and cleaned by hand it was discovered that the stage 1 shroud showed some spalled coating material. Still within the serviceable operating limits.

Picture 20: Spalled coating on stg.1 shroud

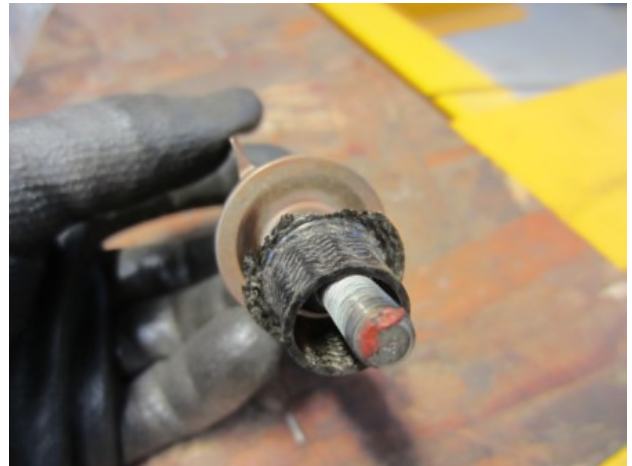
- Chafing marks were found at the hpc case outer stage 4 area, caused by the damaged actuating ring spacers.
- All hpc stage 3 to 5 washer / bushings were found worn out.

Picture 22: Worn stg.5 bushing example

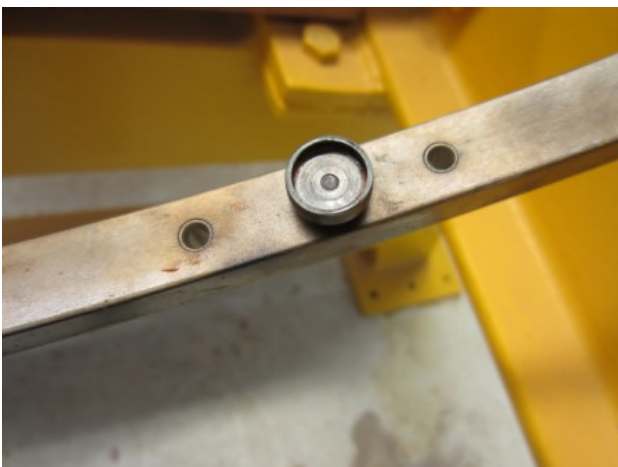
- HPC stage 4 upper and lower half rings were found with 6 missing inserts in the actuating ring spacers / stops. (3 inserts each side, upper and lower half)

Picture 23: Missing insert in actuating ring spacer

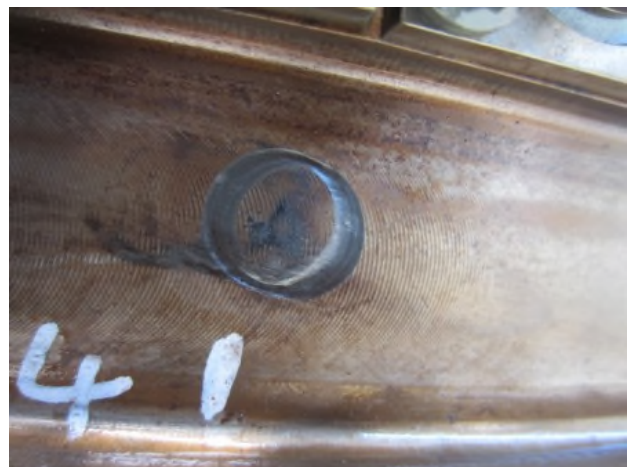
Picture 24: Chafing marks on stage 4 stator case

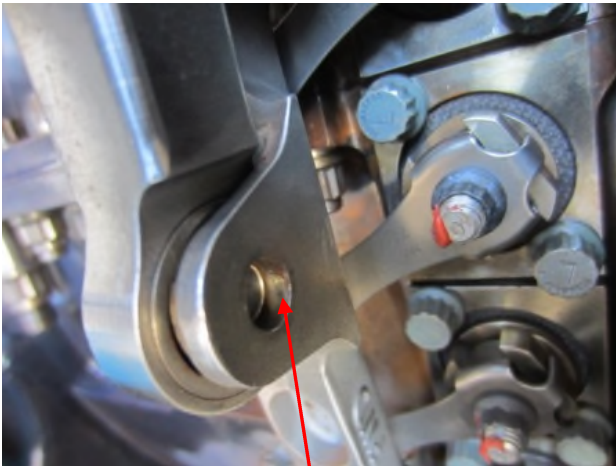
Picture 27: Stg.5 connecting link missing bushing

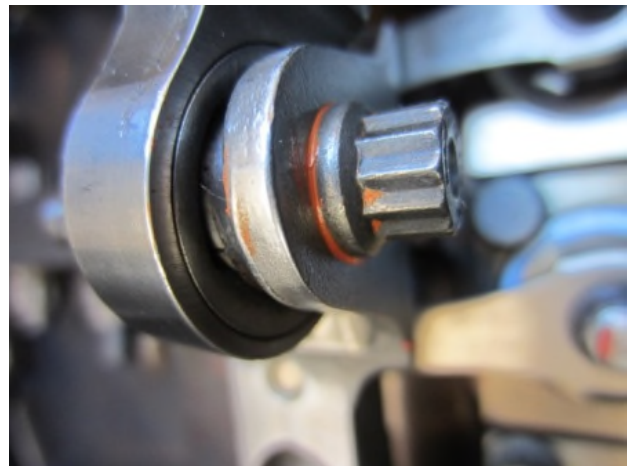
Picture 28: Red silicone in stg.5 link as support

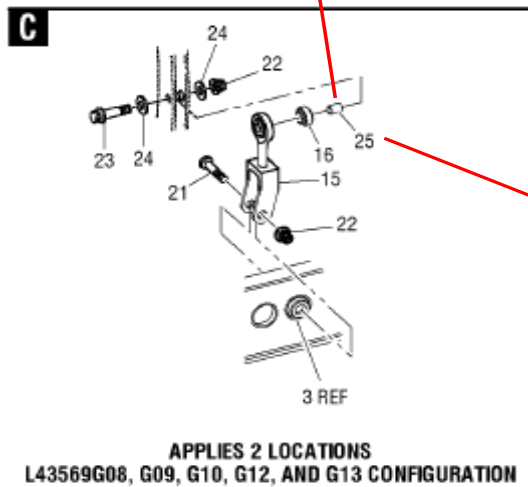
- 25 9609M88P04 .BUSHING, SLEEVE.  
 02 1332001200

Picture 29: Drawing of the missing bushing inside the connecting link of stage 5. "Item 25"
